Style 131 UltraSoft 6.5oz Navy Blue Balaclava

OBSERVATION OF WORK GARMENTS EXPOSED TO AN ELECTRIC ARC

ASTM F2621 - 12 Standard Practice for Determining Response Characteristics and Design Integrity of Arc Rated
Finished Products in an Electric Arc Exposure

Kinectrics Inc. Report No.: K-418839-53-R00

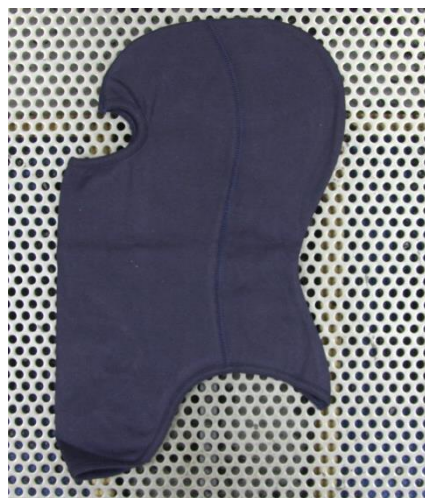
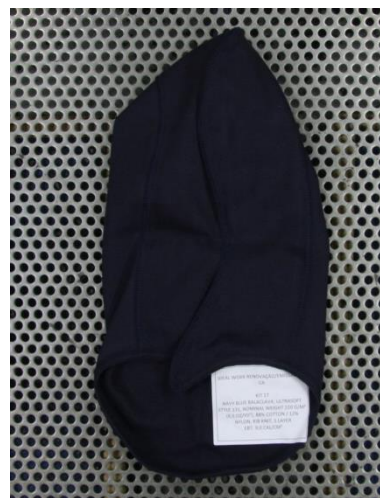
Photographs of Garments

General Garment	Shot #: 15-6103B	Shot #:	Shot #:
	Cal/cm ² 12.2	Cal/cm ²	Cal/cm ²
Break-open through the garment: <i>y/n & area</i>	N		
Number layers with ablation: <i># of ablation layers for multi layer</i>	0		
Afterflame (sec) and location:	0		
Ignition of any component: (Y/N)	N		
Melting & dripping: <i>y/n & area</i>	N		
Shrinkage: <i>None, slight, moderate or major</i>	Slight		
Closure			
Closure operable : <i>y/n</i>	N/A		
Failure of closure : <i>y/n & area</i>	N/A		
Indicator fabric			
Used in evaluation: (<i>y/n</i>)	N		
Indicator fabric description: <i>(ex 4.5 oz/yd² white 100% cotton)</i>	N/A		
Ignition: (<i>y/n</i>)	N/A		
Condition of indicator fabric:	N/A		
Summary			
Any observation of inconsistencies with the response of the fabric or concerns with the assembly of the garment. <u>Note:</u> See below for any deficiencies or concerns that may require changes to the garment assembly or design.	None

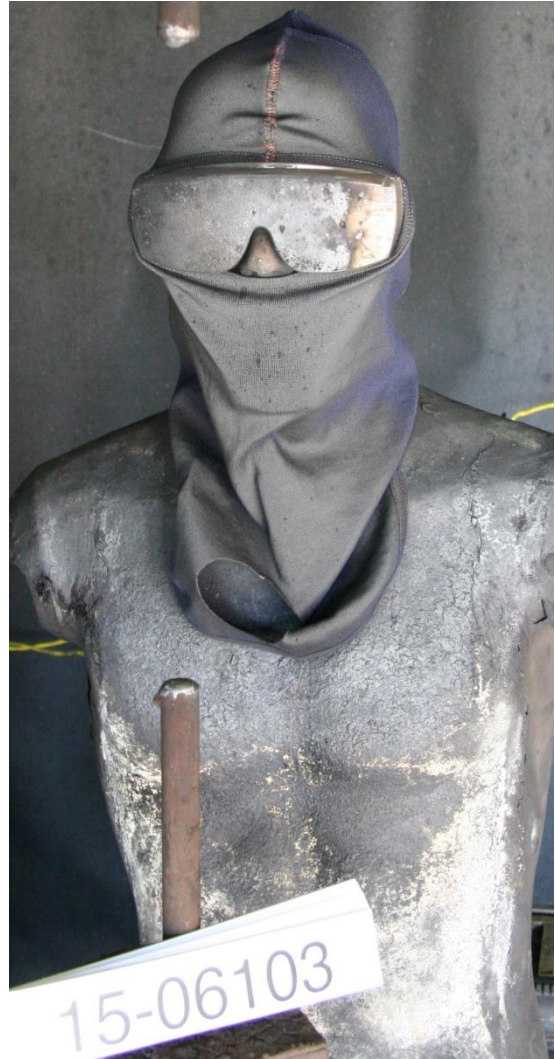
After Arc Exposure

Based on the results and observations, there are no apparent inconsistencies with the response of the fabric or concerns with the integrity of the garment.
